# Aviation Investigation Preliminary Report

<b>Location:</b>	Naples, FL	<b>Accident Number:</b>	ERA24FA110
<b>Date &amp; Time:</b>	February 9, 2024, 15:17 Local	<b>Registration:</b>	N823KD
<b>Aircraft:</b>	BOMBARDIER INC CL-600-2B16	<b>Injuries:</b>	2 Fatal, 4 Minor
<b>Flight Conducted Under:</b>	Part 135: Air taxi & commuter - Non-scheduled

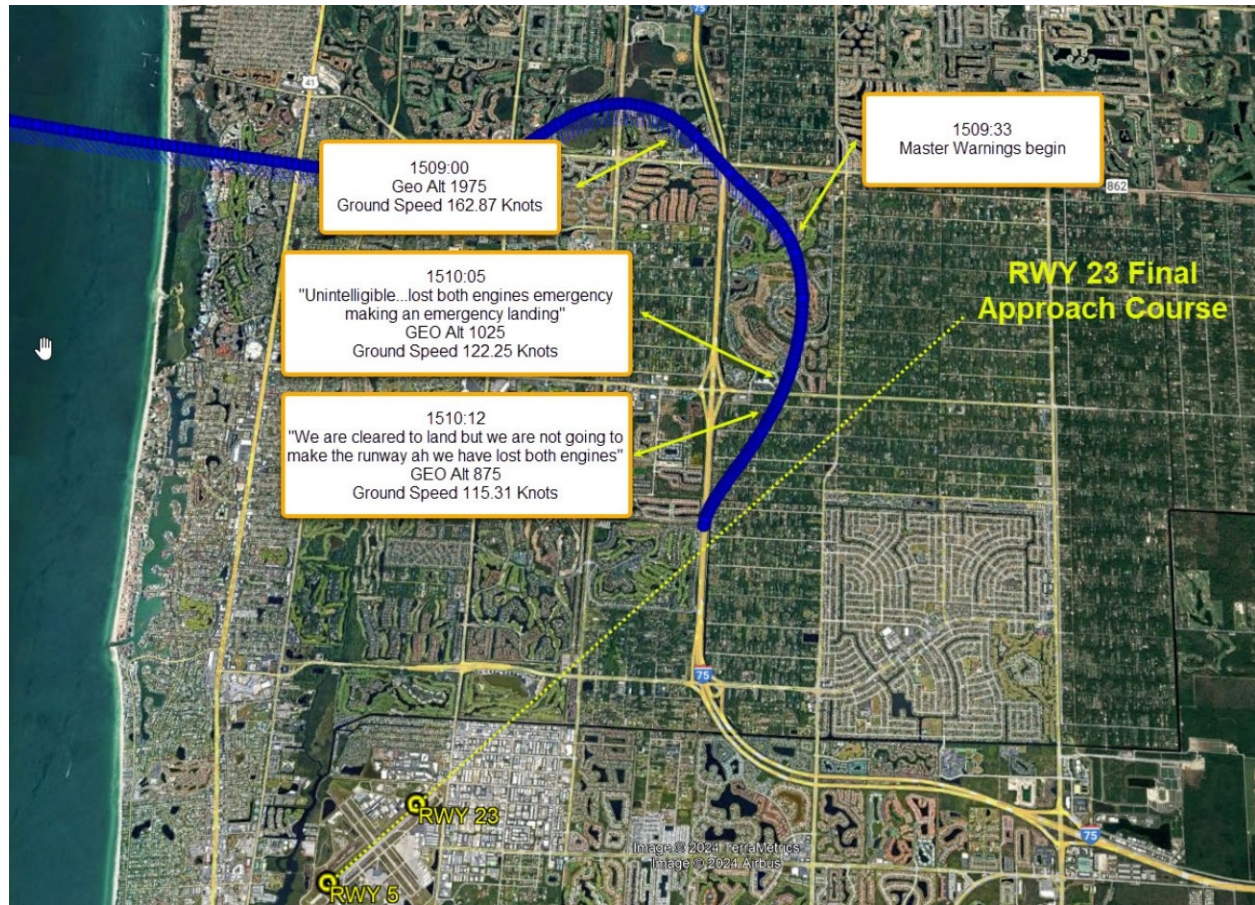
A preliminary review of the data recovered from the airplane's flight data recorder revealed that the first of three Master Warnings was recorded at 1509:33 (L ENGINE OIL PRESSURE), the second immediately following at 1509:34 (R ENGINE OIL PRESSURE), and at 1509:40 (ENGINE). The system alerted pilots with illumination of a "Master Warning" light on the glareshield, a corresponding red message on the crew alerting system page and a triple chime voice advisory ("Engine oil").

Twenty seconds later, at 1510:05, about 1,000 ft msl and 122 kts, on a shallow intercept angle for the final approach course, the crew announced, "...lost both engines... emergency... making an emergency landing" (see figure 1). The tower controller acknowledged the call and cleared the airplane to land. At 1510:12, about 900 ft and 115 knots, the crew replied, "We are cleared to land but we are not going to make the runway... ah... we have lost both engines."

Figure 1 – Plot of the airplane's ADS-B ground track (blue dots) with annotations of specific events during the approach that include time as well as the airplane's geometric altitude and groundspeed (source: Federal Aviation Administration).

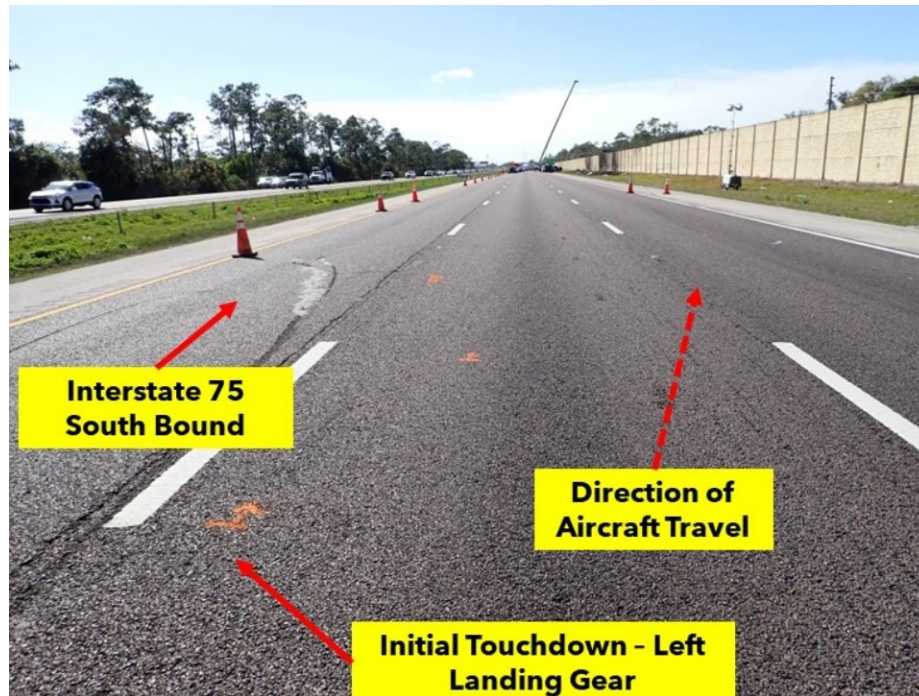
Examination of the accident site revealed tire marks on the southbound lane of Interstate 75 consistent with the left main landing gear (see figure 2). The airplane came to rest about 1,000 ft past the initial touchdown point, upright in the grass area between the break-down lane and the sound barrier wall facing north, opposite the direction of travel.

Figure 2 Annotated photograph of the airplane's initial touchdown point on Interstate 75.

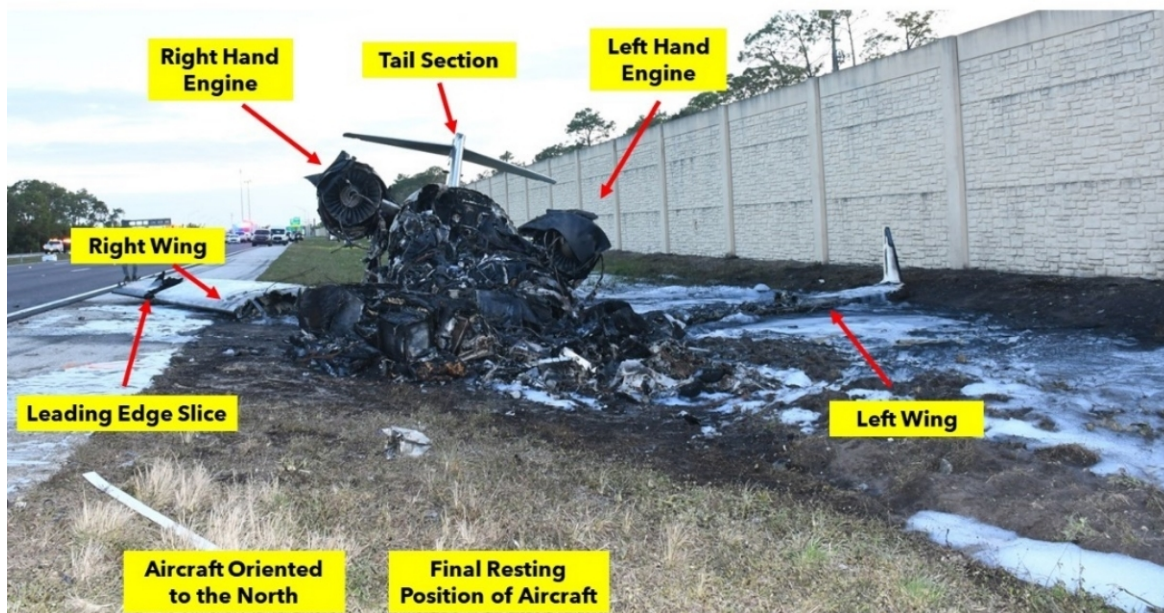
The forward portion of the fuselage was consumed by the post-impact fire (see figure 3). All major components of the airplane were accounted for at the scene, and the ground surrounding the wreckage was fuel-soaked having an odor consistent with Jet-A fuel. The cockpit center console was found separated from the main wreckage. Both engine throttle levers were found near the IDLE stop position. The flap selector handle was found in a position consistent with 45° flap extension.

Figure 3 – Annotated photograph of main wreckage as found.
