Montauk, NY
September 16, 2018
N161DL
SR22-4128 (G5)
C of A: 9/16/2014

NTSB Preliminary Report

Subject: ERA18LA253 Montauk, NY
Name: Richard Tasca – Pilot

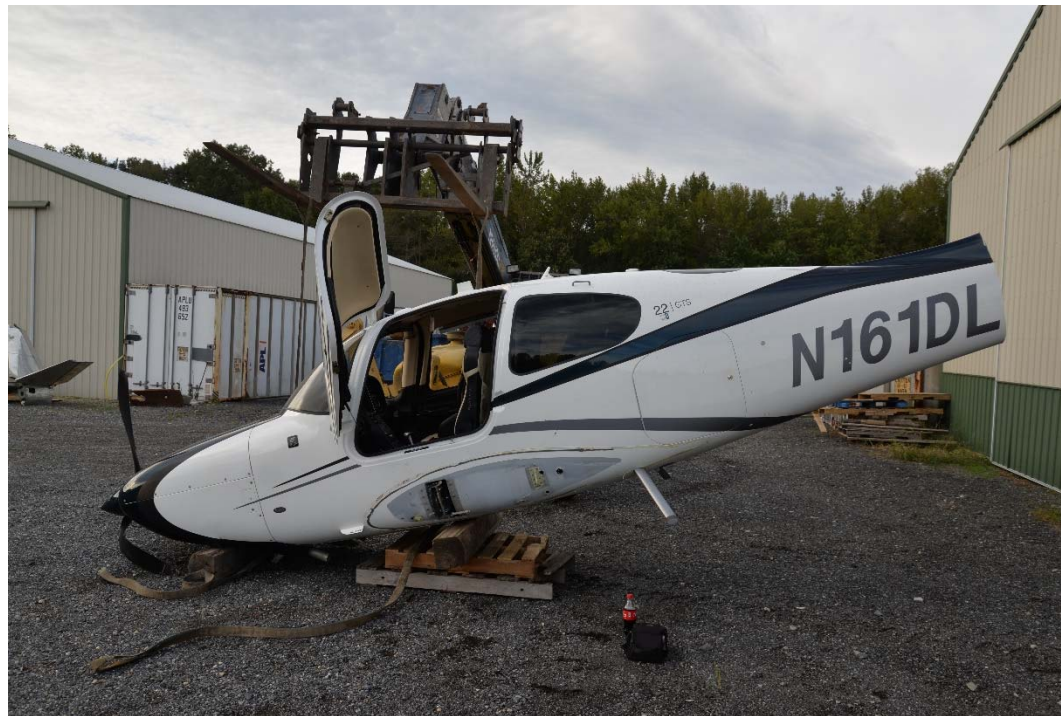
Airplane During Examination

Examination of photographs revealed that the wings, fuselage, and empennage all sustained substantial impact damage. An FAA inspector who responded to the site said he could not enter the cockpit, as the door was either locked or impinged by impact damage.

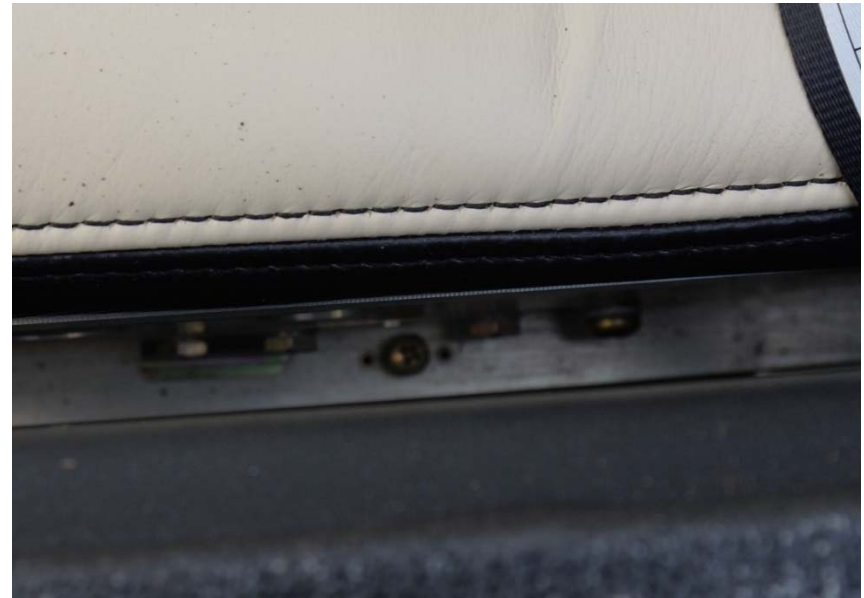
Location of Seat as Found

- Seat was located in last adjustment hole prior to seat stop
- Seat stop was present and secure

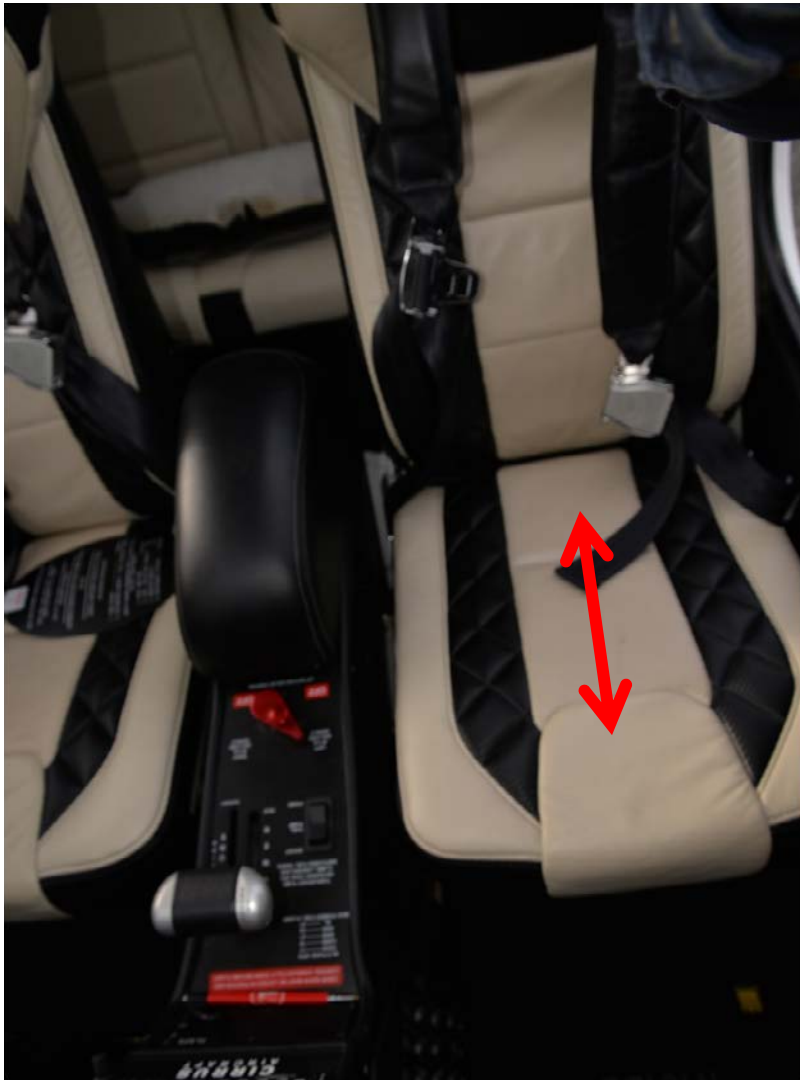
Inspection Observations

- Movement of seat fore and aft was easily accomplished
- No binding or anomalous behavior noted
- Seat good according to AMM 25-10 (5)(b) inspection criteria
- BOTH pins locked into position simultaneously and freely in all adjustment positions

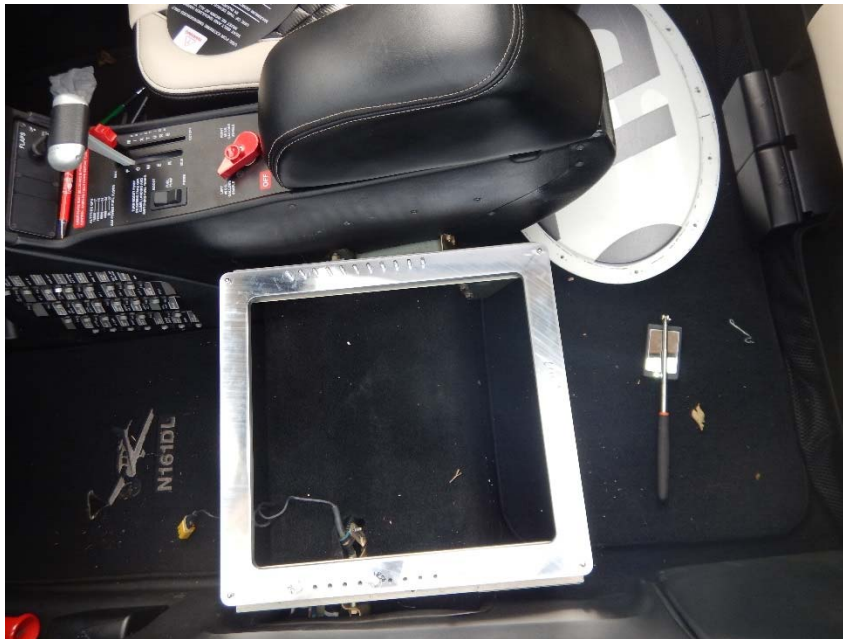
Inspection Observations

- Tool # 11123
 - Used in production to verify track holes are aligned and not offset from one another
- Gage verified holes in tracks on N161DL were aligned with one another
- Side play in seat tracks is normal
- Side play of inboard seat rail could be manipulated to the point of not being able to seat gage pins on one side

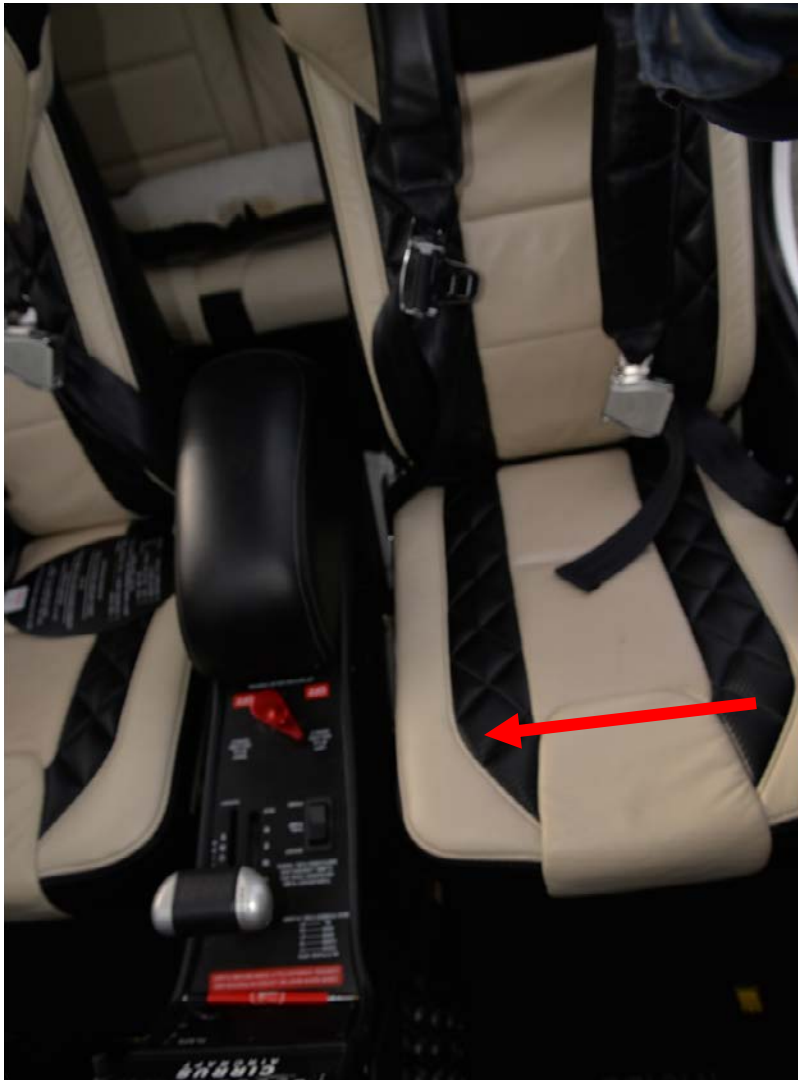
Inspection Observations

- With seat twisted hard to right while sitting in seat and while being slid forward, partial pin engagement could be made to occur
- Once partial engagement occurred then:
 - Unable to move adjustment lever to full down position (see placard & POH)
 - Downward force would not force pins into lock position
 - As soon as seat straightened or an attempt to move the seat forward occurred full pin engagement would occur
 - Same would occur on co-pilot seat but much more difficult to reproduce due to not as much ease of side play in system
