Number: SB 2X-32-19 R3

SNS SUBJECT: 32-20 NOSE GEAR - Nose Landing Gear Assembly Inspection and Reinforcement

Some SR22 aircraft have developed cracks in the upper section of the nose landing gear (NLG). The cracks develop on the NLG assembly through the cross tube welds and gusset plate. To address this potential condition, a reoccurring inspection of the upper gusset plate, and forward surface of forward weld between the cross tube and strut is required.

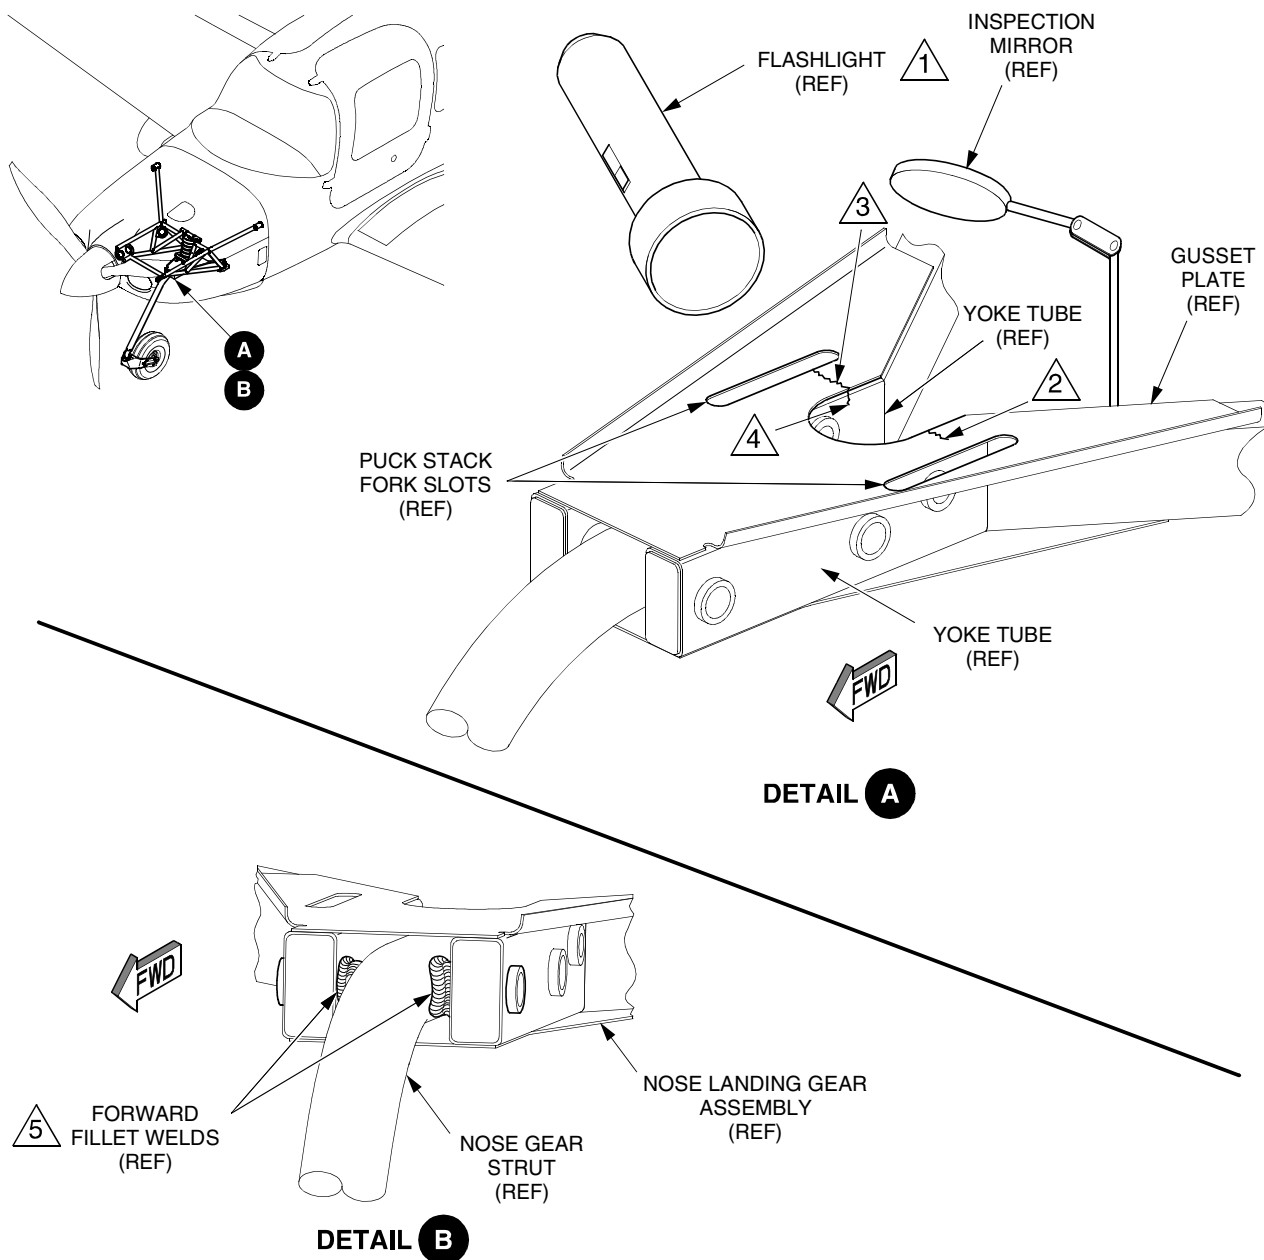
Figure 1
Nose Landing Gear Assembly Inspection

At upper gusset plate, use flashlight and inspection mirror to visually inspect in accordance with FAA AC 43.13-1B, Chapter 5, Section 2 for evidence of cracking developing through the gusset plate and extending toward the puck stack fork slots.

(1) At upper section of nose gear strut where strut enters the NLG assembly, use flashlight and 10X magnifier to visually inspect forward surface of forward fillet welds attaching strut to NLG assembly in accordance with FAA AC 43.13-1B, Chapter 5, Section 2 for indications of damage. If welds show indications of damage (i.e. cracks, rust lines, loose paint), determine extent of damage.

- 1 At upper gusset plate, use flashlight and inspection mirror to visually inspect upper gusset plate for evidence of cracking developing through the gusset plate and extending toward the puck stack fork slots in accordance with FAA AC 43.13-1B, Chapter 5, Section 2.

- 2 If crack does not extend into yoke tube, and does not reach either puck stack fork slot, crack length is allowable for continued operation. Re-inspect Upper Gusset Plate every 100 flight hours in accordance with Chapter 5-20, Scheduled Maintenance Checks.

- 3 If crack reaches either puck stack fork slot, NLG assembly must be replaced within 100 flight hours.
- 4 If crack extends into yoke tube, contact Cirrus Design for disposition.

- 5 At upper section of nose gear strut where strut enters the NLG assembly, use flashlight and 10X magnifier to visually inspect the forward surface of the forward fillet welds attaching the strut to the NLG assembly in accordance with FAA AC 43.13-1B, Chapter 5, Section 2.

- If no cracking is found, re-inspect Upper Gusset Plate every 100 flight hours in accordance with Chapter 5-20, Scheduled Maintenance Checks. (Refer to AMM 05-20)
- If cracking is found but does not extend into yoke tube, and does not reach either puck stack fork slot, crack length is allowable for continued operation. Re-inspect Upper Gusset Plate every 100 flight hours in accordance with Chapter 5-20, Scheduled Maintenance Checks. (Refer to AMM 05-20)
- If crack reaches either puck stack fork slot, NLG assembly must be replaced within 100 flight hours. (Refer to AMM 32-20)
- If crack extends into yoke tube, contact Cirrus Design for disposition.

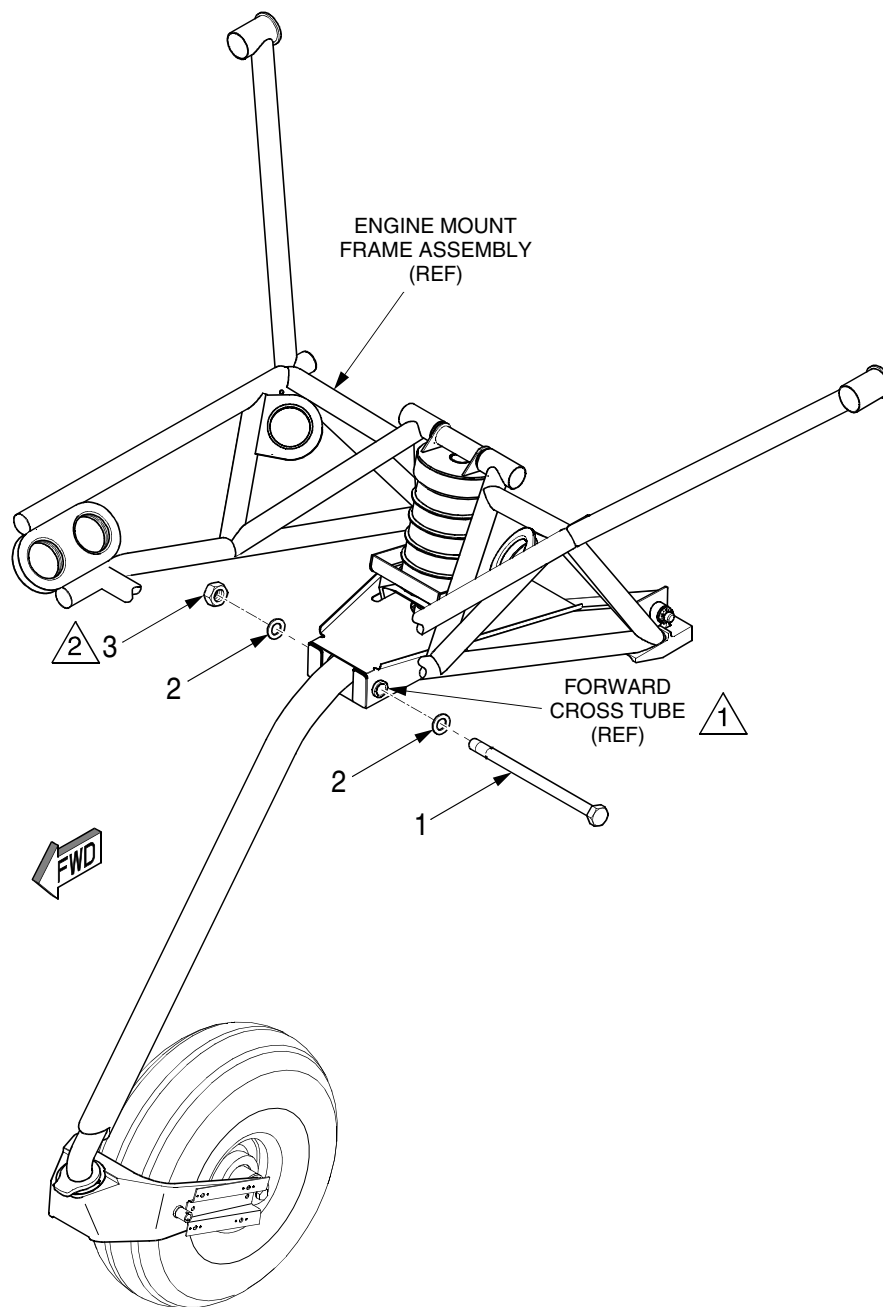
Figure 2
Nose Landing Gear Assembly Reinforcement

If evidence of cracking is identified, it may be necessary to install hardware through the forward cross tube of the NLG assembly to strengthen load capabilities of the cross tube and prevent further cracking.

- (2) Apply sufficient grease to fully coat bolt.
 - (3) Ensure bolt passes through forward cross tube of NLG assembly. If necessary, lightly tap bolt through forward cross tube with hammer.

- (4) If inner diameter of cross tube prevents bolt insertion, use reamer to enlarge cross tube to 0.635 inch (16.129 mm) maximum.
 - (5) Using compressed air, remove any debris from forward cross tube.

- (6) Install bolt, washers, and nut through forward cross tube of NLG assembly. Torque to 1100 to 1300 in-lb (124.3 to 146.9 Nm).
- G. Apply paint and primer to inspection areas as necessary. (Refer to AMM 51-20)

- ① If inner diameter of cross tube prevents bolt insertion, use reamer to enlarge cross tube to 0.635 inch (16.129 mm) maximum.
- ② Torque to 1100 to 1300 in-lb (124.3 to 146.9 Nm).
